A lime based mortar for thermal insulation of medieval church vaults

Publication date:
2016

Citation (APA):
Hansen, T. K., Larsen, P. K., Hansen, K. K., Bjarløv, S. P., & Peuhkuri, R. H. (2016). *A lime based mortar for thermal insulation of medieval church vaults*. Paper presented at Historic Mortars Conference 2016, Santorini, Greece.

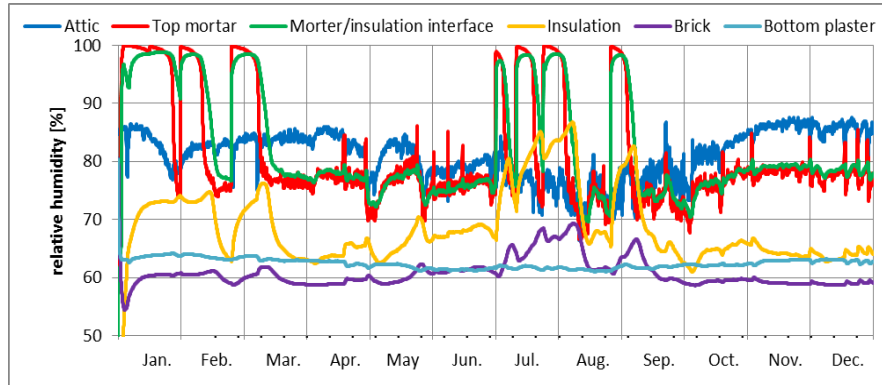
Figure 3: Yearly simulation of church vault with 100mm insulation mortar

Simulation results of relative humidity through the construction are expressed in Figure 3.

The simulation results indicated that only the upper three output points were clearly affected by the exterior water loads. The exterior water loads added in winter and summer, seemed to have a significant influence on humidity conditions in layers down to the middle of the insulation layer, but not further, towards the brick layer. It was seen, that the interface area between brick and insulation, as well as the middle of the brick layer, was influenced during summer periods, but to no severe extent. In the summer period the superficial layers dried out quicker than in winter due to increased temperature, which also made the vapour pressure in the attic increase and cause the deeper penetration of moisture during summer. Neither the bottom part of the brick or the bottom layer of plaster was affected by the external water loads at any time.
